## SECTION 4. STREAM, WETLAND, AND FOREST REHABILITATION OPPORTUNITIES

### 4.1 Stream Rehabilitation Opportunities

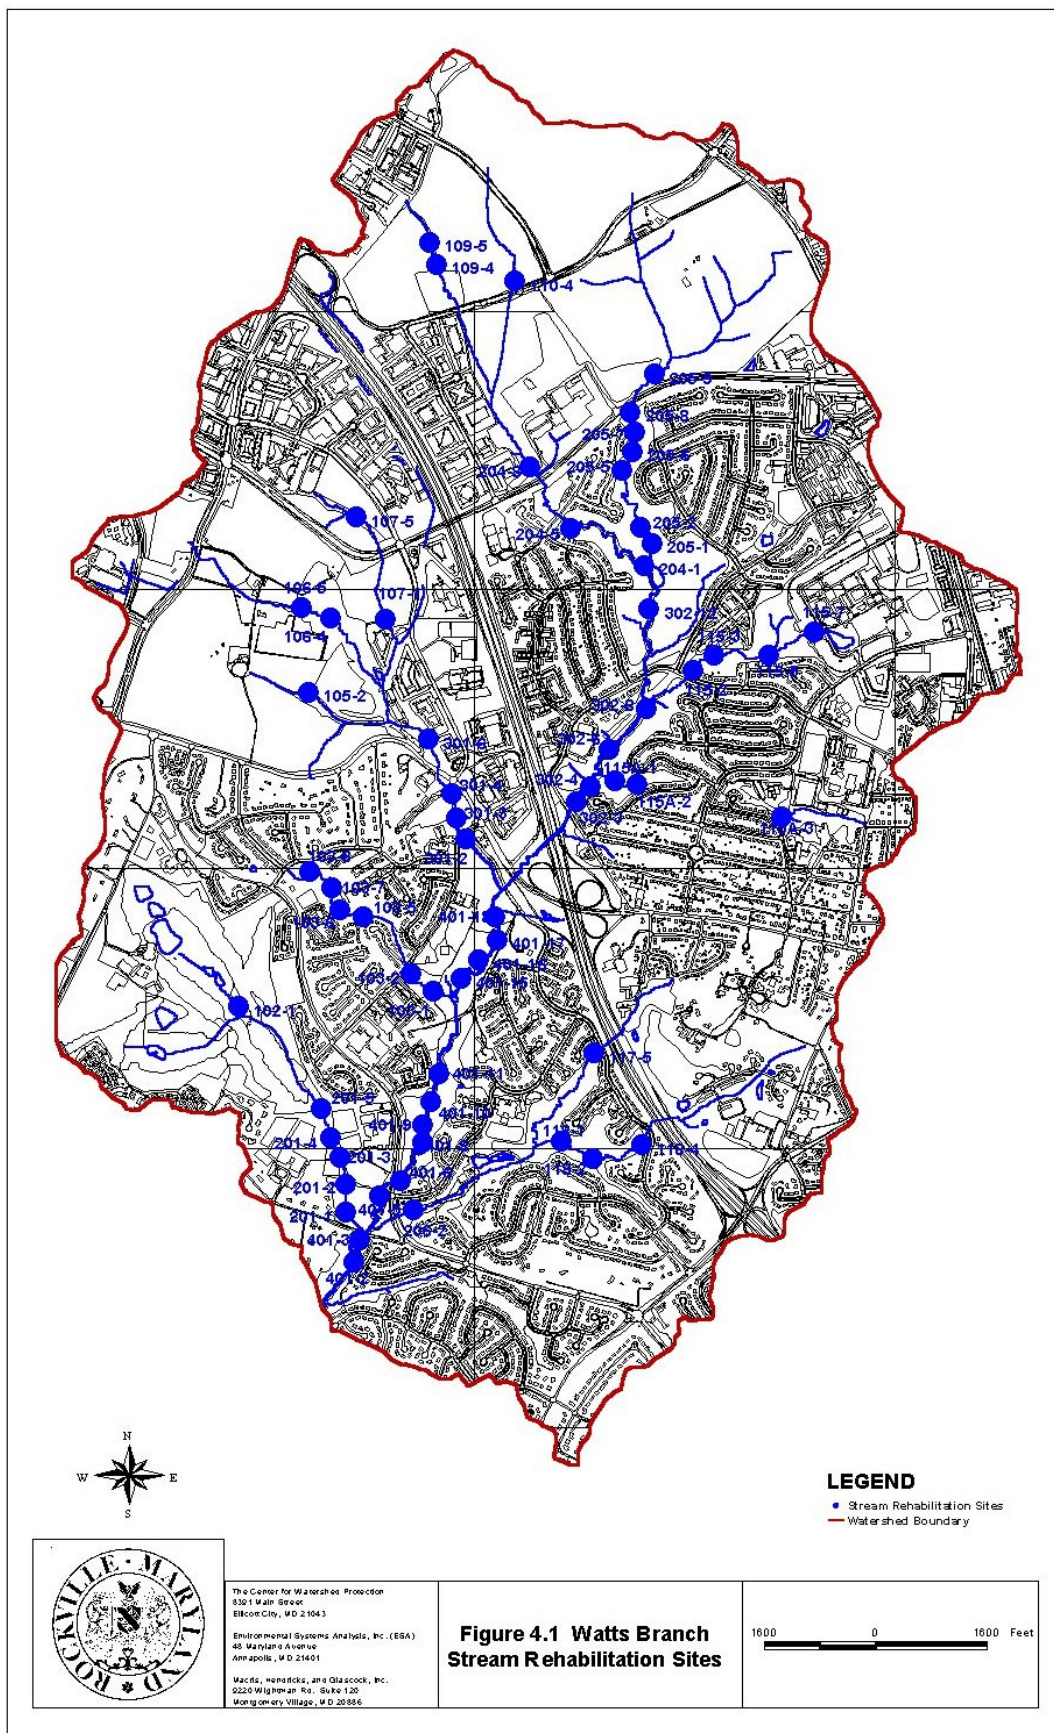
**Figure 4.1 Watts Branch Stream Restoration Sites**

A total of 62 stream reach locations were identified as being in need of stabilization or rehabilitation, as part of the RSAT assessment (see Figure 4.1). Where appropriate, adjacent locations were combined to form a single rehabilitation site. Using this approach, 35 stream reach rehabilitation sites were identified. This section presents an inventory and describes the ranking system used to document which stream rehabilitation projects have the highest priority for implementation. Lastly, this section presents the list of the highest priority sites.
